PHASE II SITE CHARACTERIZATION REPORT FOR THE SILVER CREEK DRAINAGE PROJECT

Lewis & Clark County, Montana

DEQ Contract No. 401026

January 2003

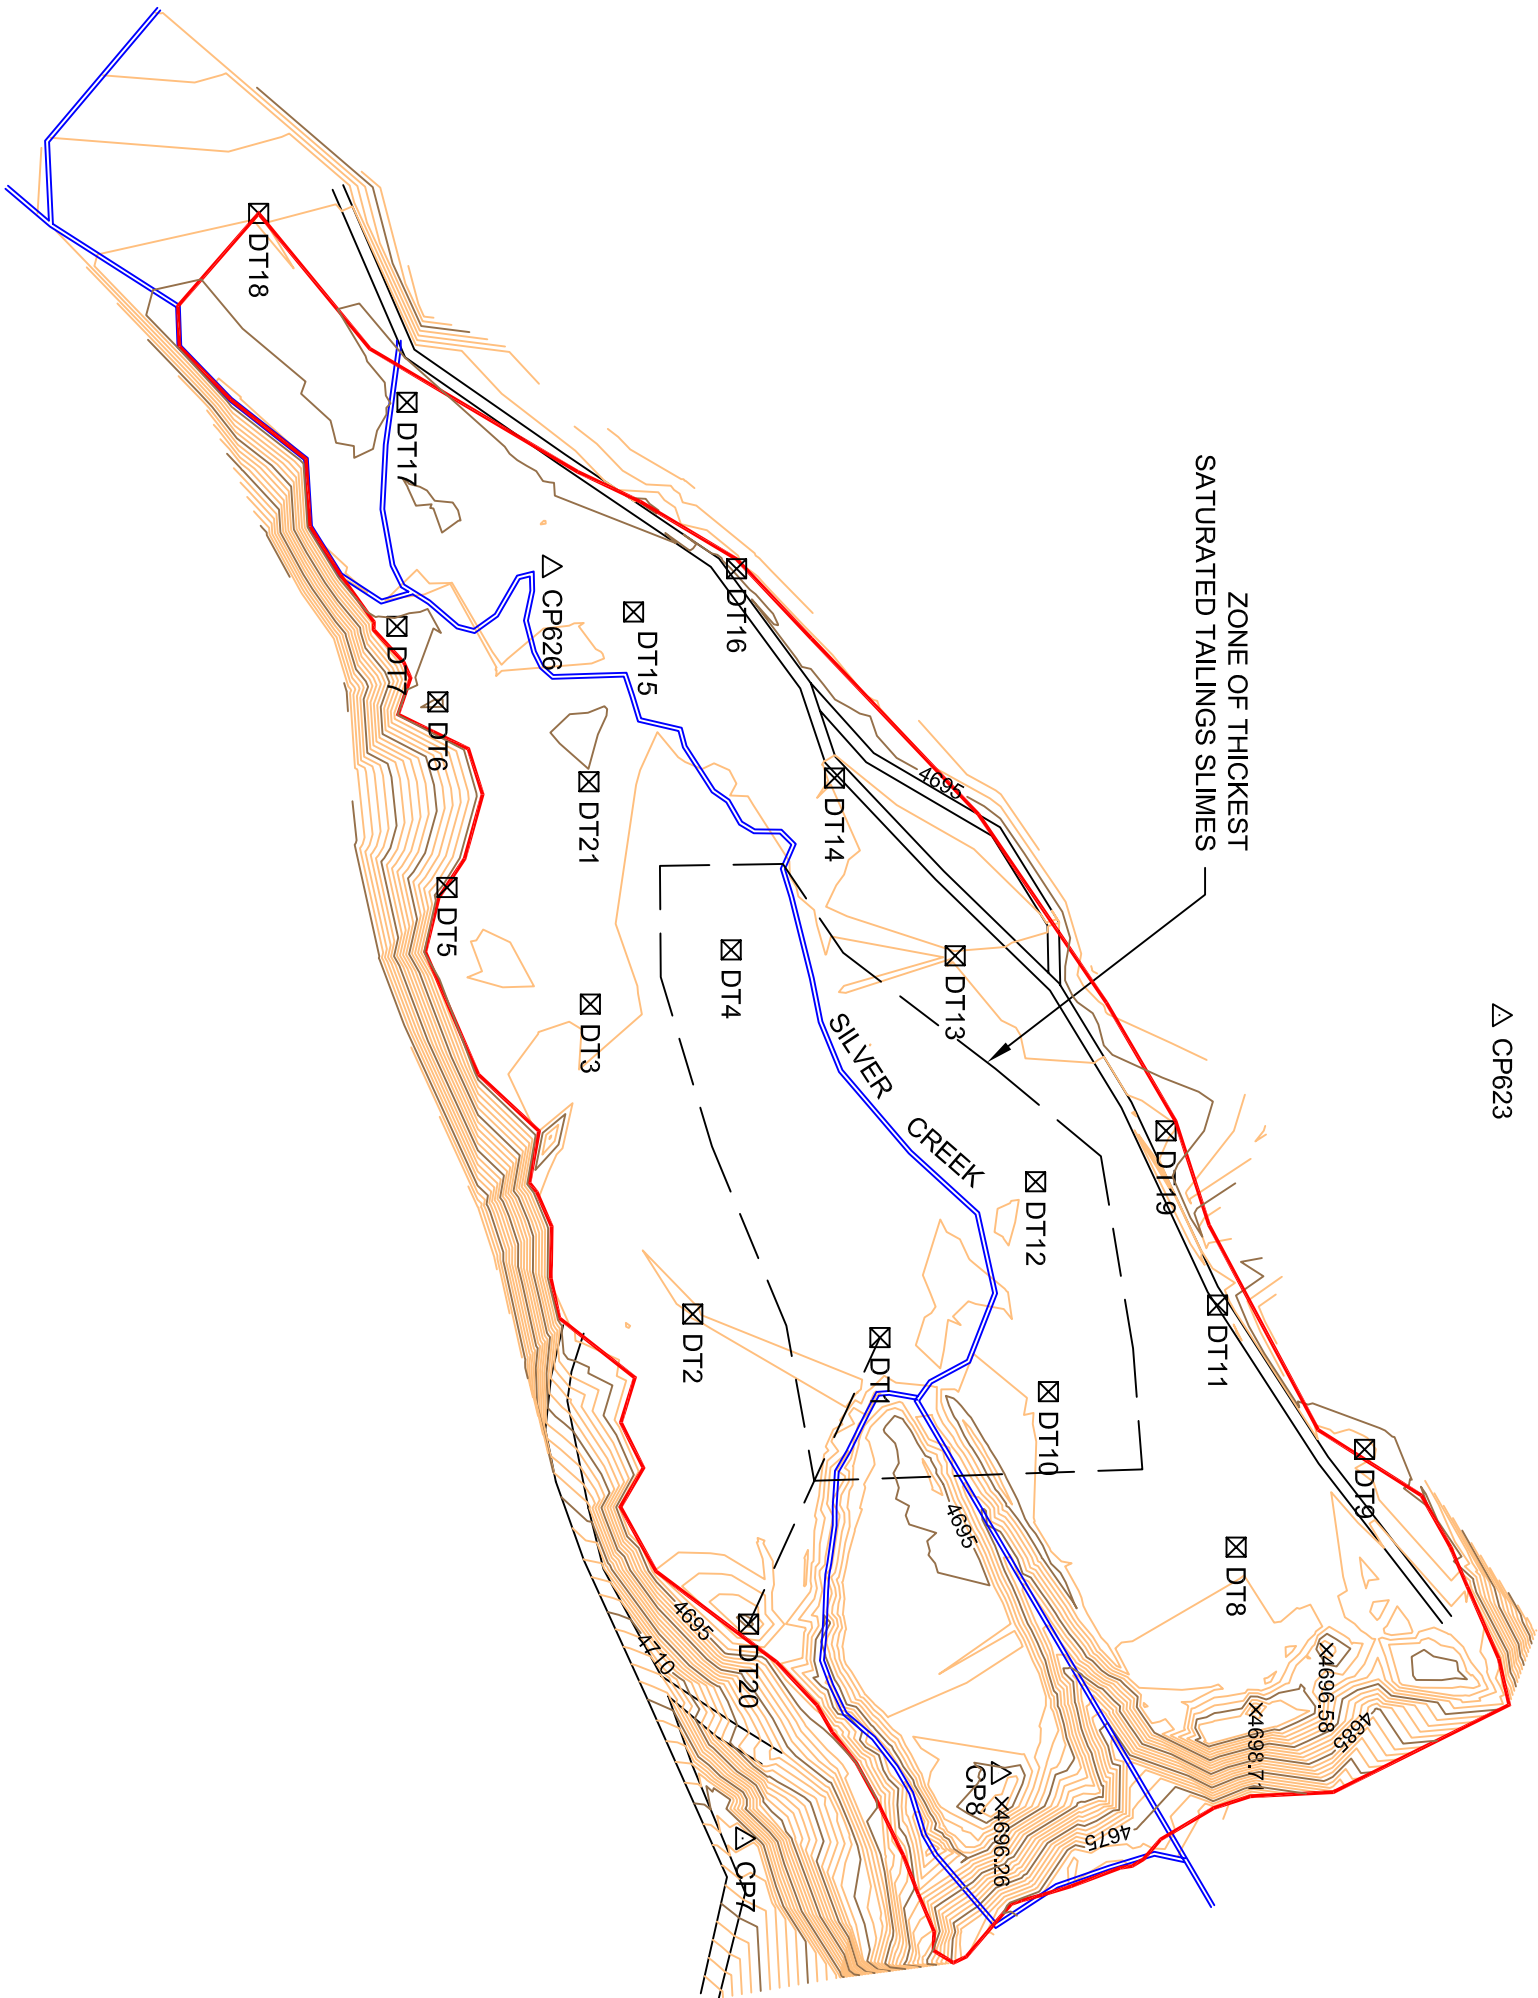
DESIGN:	DRAWN: KSR	CHECKED: cs	MONTANA DEQUINE WASTE CLEANUP BUREAU SILVER CREEK DRAINAGE PROJECT LEWIS & CLARK COUNTY, MONTANA		DRUMLUMMON TAILINGS AREA	FIGURE 6-1
				APPROVED:	DATE: 8/2002	JOB NO: A1284				
NO.	REVISION DESCRIPTION	BY	DATE	SCALE: AS SHOWN	FILENAME: A1284Druml.dwg

The estimated volume of the Drumlummon tailings pile is 59,780 cubic yards (Table 6-2). The tailings plan area is 5.45 acres and the average tailings depth is 6.8 feet. The maximum tailings thickness measured in the test pits was 15 feet. A total of 21 backhoe test pits were excavated in the Drumlummon tailings.

The Drumlummon tailings pile geology is based on observations made from 21 backhoe test pits (Figure 6-1). The tailings pile is comprised predominantly of light tan to tan silty sand with variable degrees of red to orange brown iron oxide (FeOx) coloration. Lesser amounts of light greenish gray, silty sand tailings are present. The silty sand tailings is generally dry, but some areas may contain slight moisture. Thin bands, streaks and clots of moist silty clay may be present in the silty sand tailings. More clay-rich tailings slime zones are generally characterized by tan to bluish gray silty clay to clayey silt zones. The thicker tailings slime zones are commonly saturated causing very unstable pit walls in the backhoe excavations. The thicker tailings slime zones were intercepted in test pits DT1, DT4, DT10 and DT12. The areal extent of these pits indicate that the slime zone is located in the central portion of the tailings pile (Figure 6-1). The current Silver Creek channel traverses through this area.

The native surface below the tailings was intercepted in all of the test pits except for DT4 and DT10 in which saturated slimes caused major pit wall collapse. The native soils generally consist of light brown sandy gravel with rock up to 12-inch diameter. The rock is generally angular to subrounded, suggesting the native material is probably colluvium versus alluvium. The native sediments generally not did contain significant moisture. Some of this material may be related to placer operations that pre-dated the emplacement of the mill tailings. Iron oxide coloration in the native soils appears to be highly variable but generally minor in concentration with the exception of two pits, DT2 and DT12, where native sediments contain abundant orange brown FeOx.

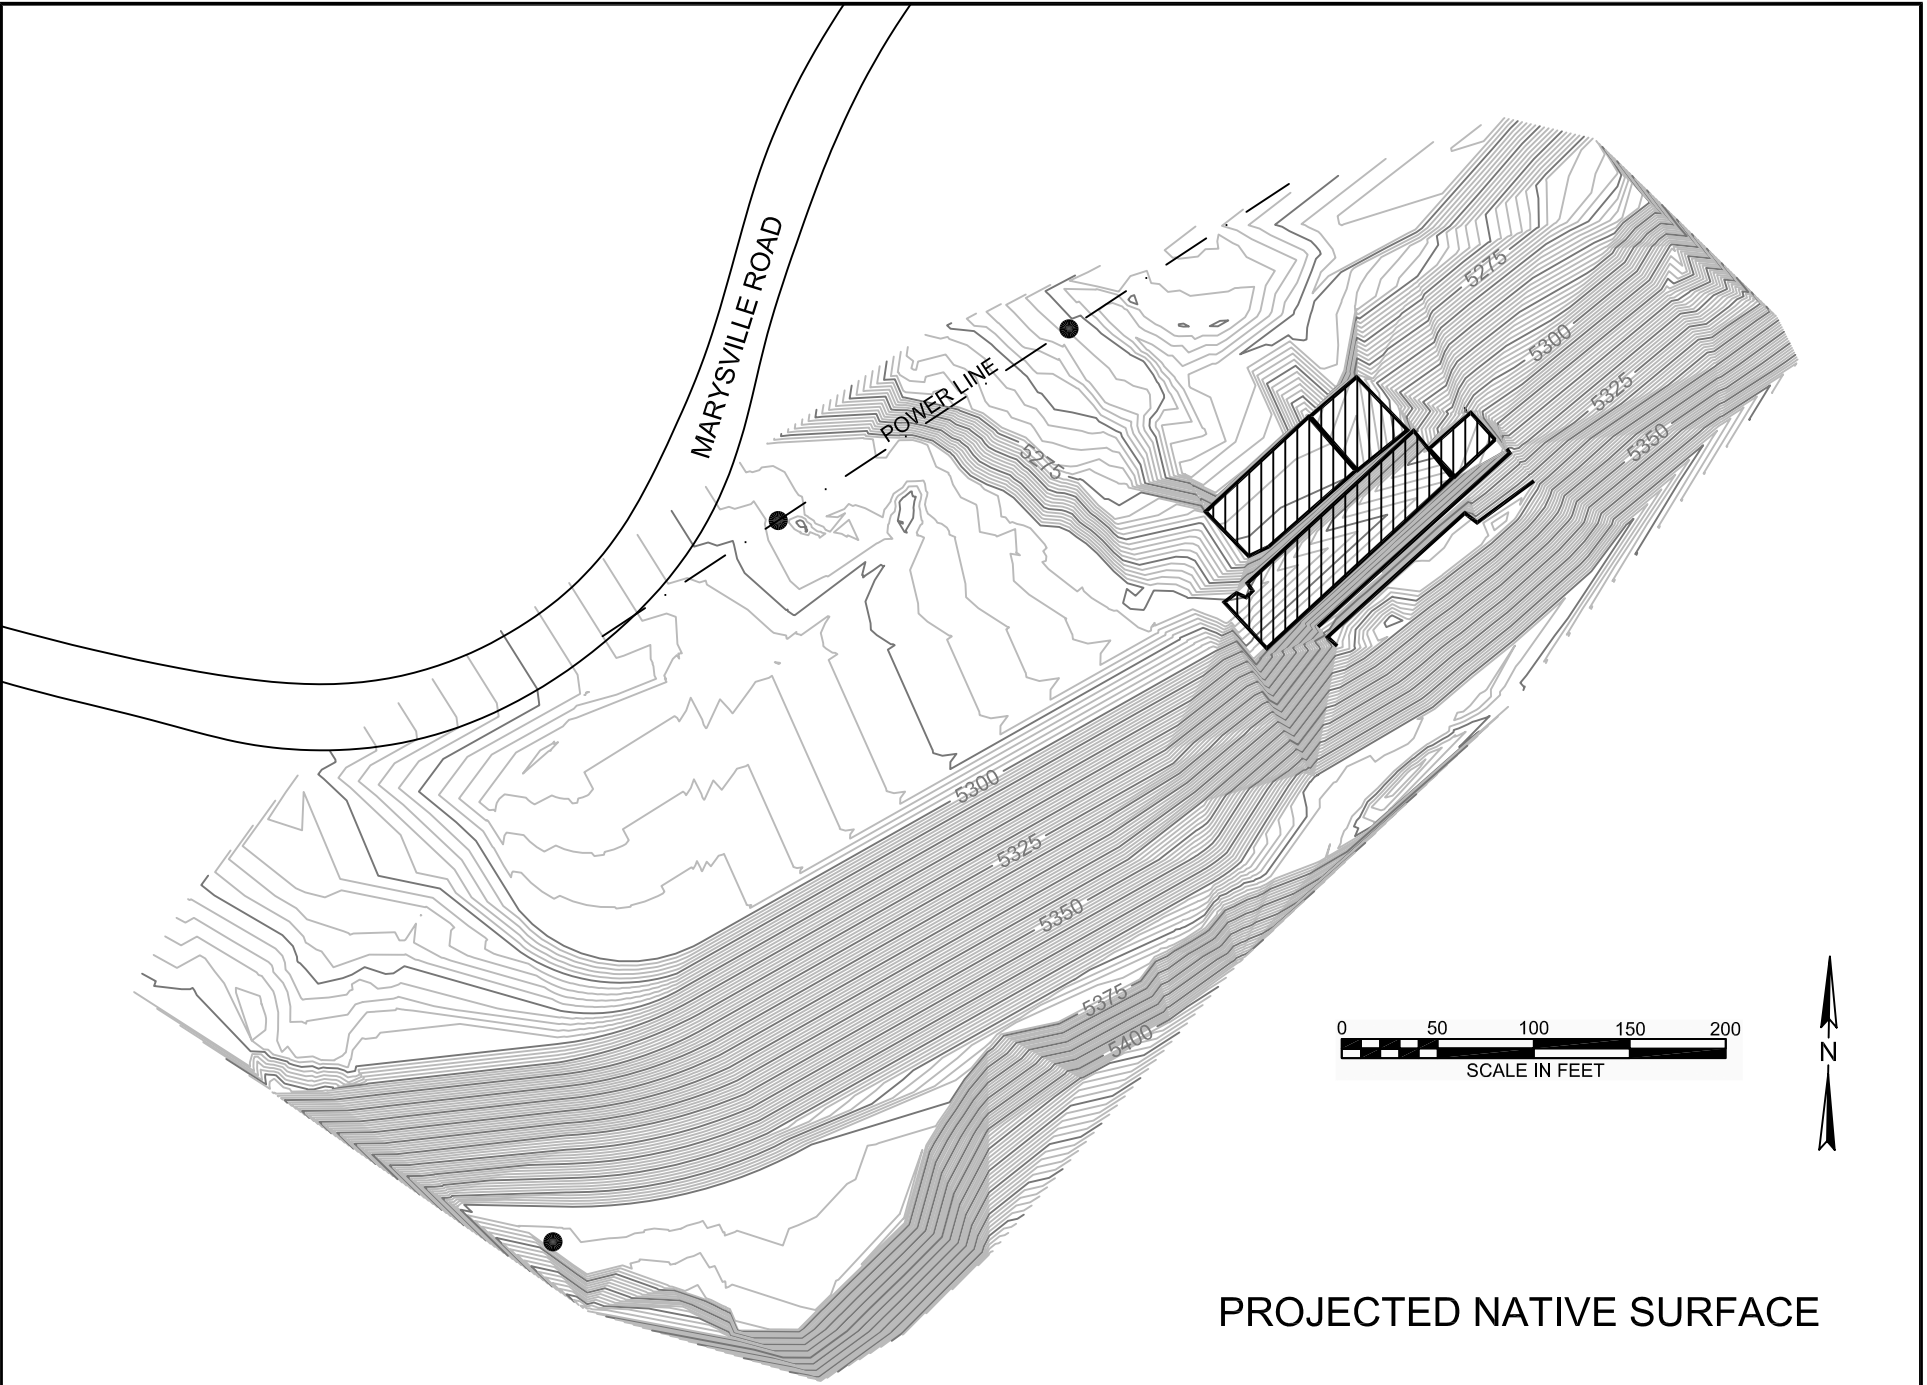
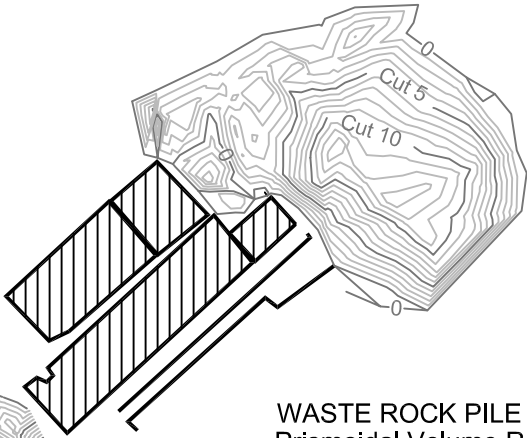
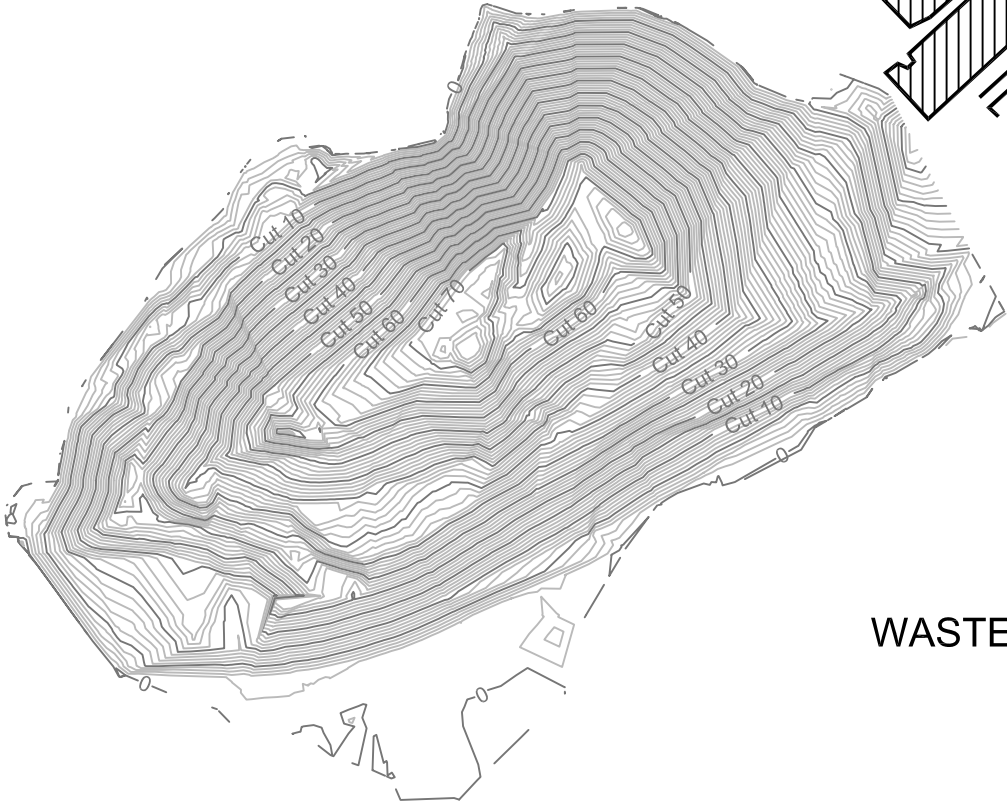
WR4. This pile has recent evidence of excavation, suggesting that it is being used as a borrow source. Excavation has also exposed thin layers (generally ≤ 6 -inch thick) of charcoal in WR4. The source of this charcoal was probably furnace charcoal generated during mill operations.
